REHABILITATION OF AN ICONIC SKYSCRAPER POISED TO SPUR REVITALIZATION OF A DOWNTOWN NEIGHBORHOOD

Robert C. Burns, AIA, LEED AP¹ and Patrick Thompson, AIA²

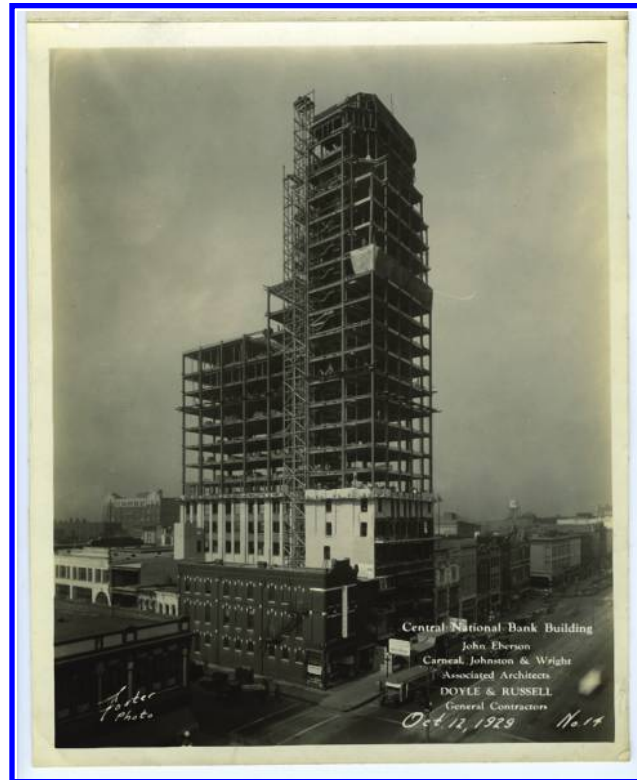
FIGURE 3: Construction Progress
Photo, October 12, 1929. ©Wolfsonian
P180217.

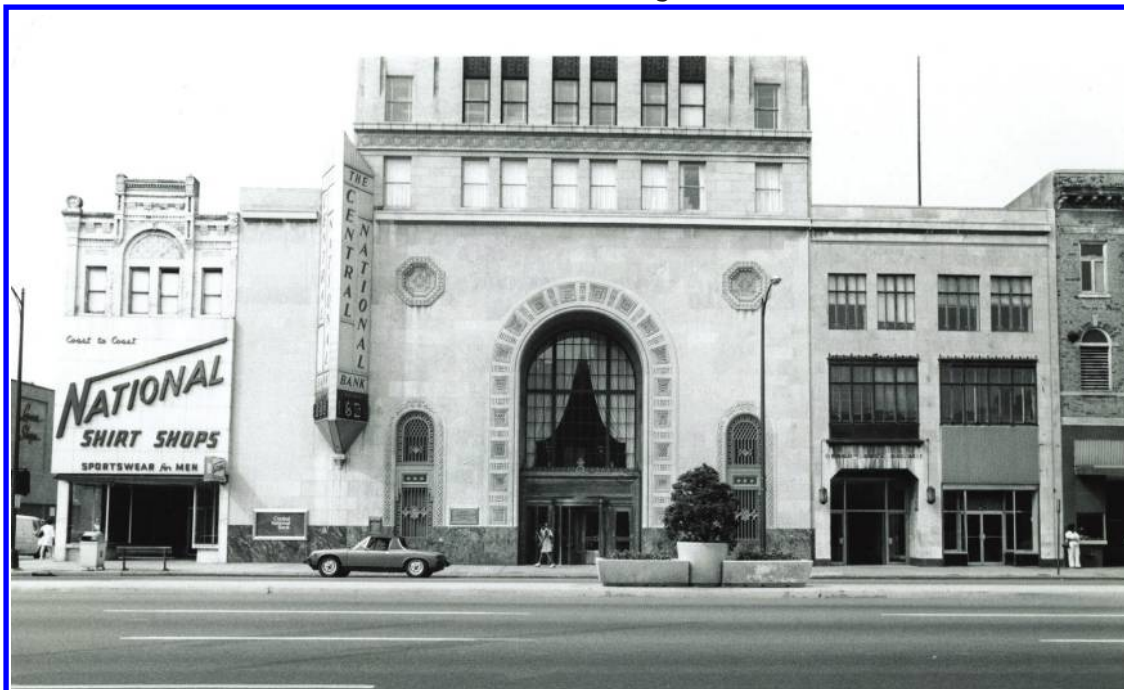
FIGURE 5: Broad Street Entrance Facade. c.1978. ©Virginia DHR Archives

The main façade fronting on Broad Street is composed of a dominant limestone two-story arched entry with a multi-paned glass transom over a substantial bronze and marble-framed entrance featuring a central revolving door. Carved low-relief voussoirs border the arch to frame the main entrance, which is balanced on either side by lower arched windows that are bordered by their own low-relief carving, this time in a zig-zag pattern. These flanking window openings are protected by ornamental bronze grillwork. We can see that every aspect of the careful and sober design of the building entrance, from the selection of sturdy limestone as the dominant material to the use of symmetry as a compositional theme, is crafted to provide a sense of strength and stability for the new bank.

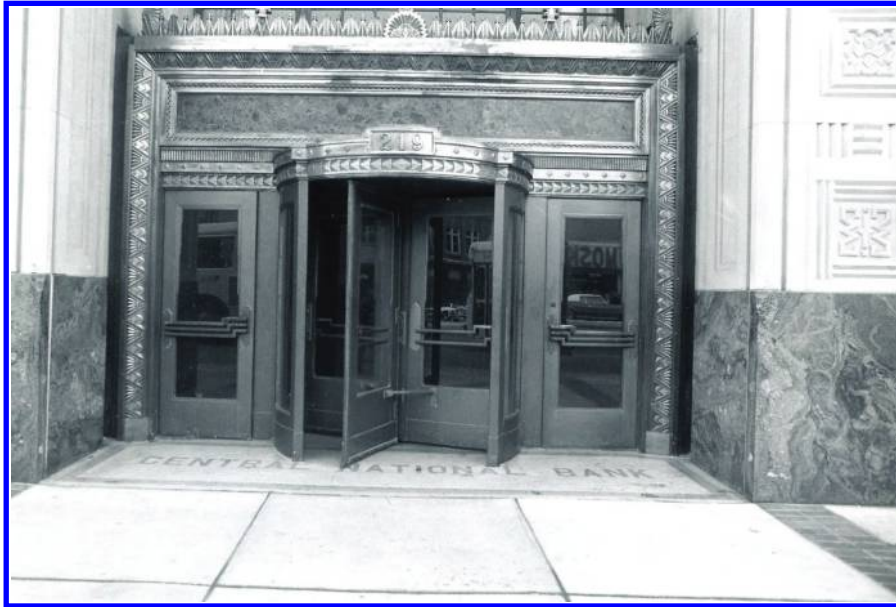
FIGURE 6: Broad Street Entrance Revolving Doors. c.1978. ©Virginia DHR Archives.

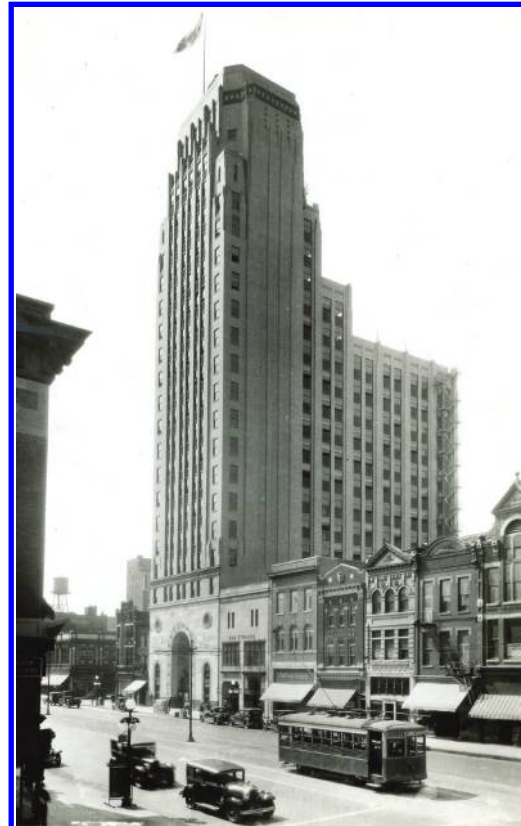
FIGURE 7: Broad Street Tower View from Northwest. c.1938. ©Virginia DHR Archives.

The upper stories of the tower façade are marked by vertical strips of windows and brick pilasters with decorative brick panels used to separate the windows horizontally. The brick pilasters soar upward into the sky until they reach their termination as pinnacles against the uppermost two floors of the building, crowned by an ornamental band of brick in a diamond pattern. As it approaches the sky, the building steps back in a ziggurat type configuration found on many Art Deco skyscrapers.

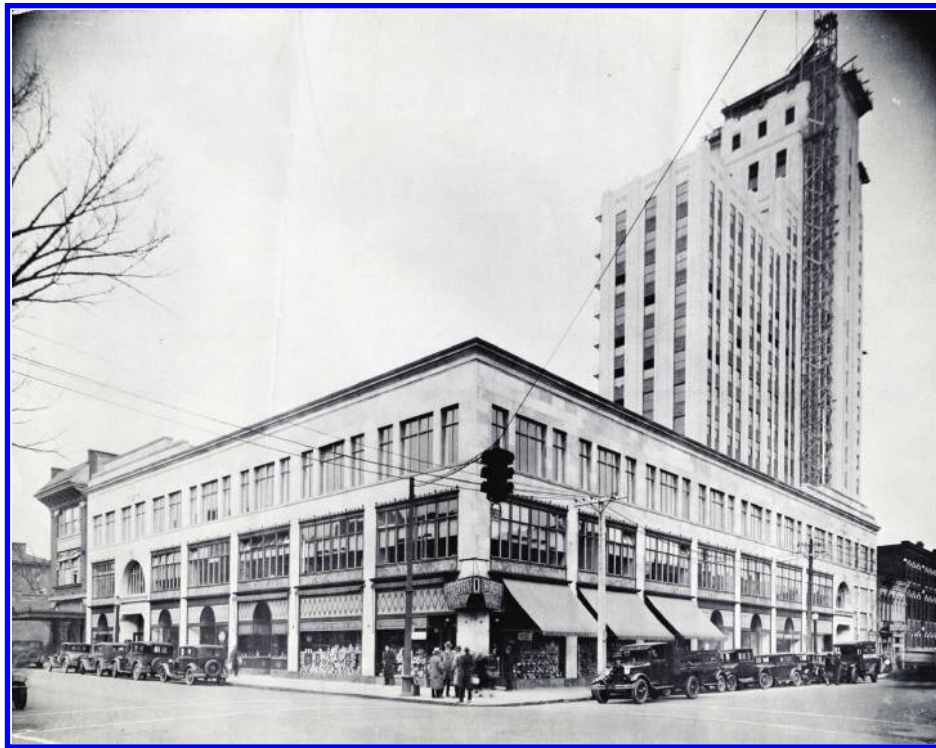
FIGURE 8: Broad-Grace Arcade viewed from the corner of Grace and 3rd Streets. c.1938. ©Virginia DHR Archives.

Adjacent to and surrounding the main tower building on three sides, Eberson designed the smaller three-story structure designed to house individual retail tenants, which was known as the Broad-Grace Arcade. Clad in limestone to match the adjacent entrance to the bank building on Broad Street, the arcade building is capped by a denticulated cornice line that is an inferred extension of the cornice found on the Broad Street entry façade and serves to visually unify the two buildings façade design. While the individual shops fronting the streets each had their own entrances, public entrances to the interior portion of the arcade were also provided on Broad, Grace and 3rd Streets. These public entrances to the interior retail areas of the arcade were composed of smaller scale simplified arches reminiscent of the main entrance on Broad Street, with casement type transom doorways flanked by brass lanterns and cast bronze grillage to mark the entrances. A fourth story was added to the Arcade in 1938 and the Broad-Grace Arcade later became known as the Annex.

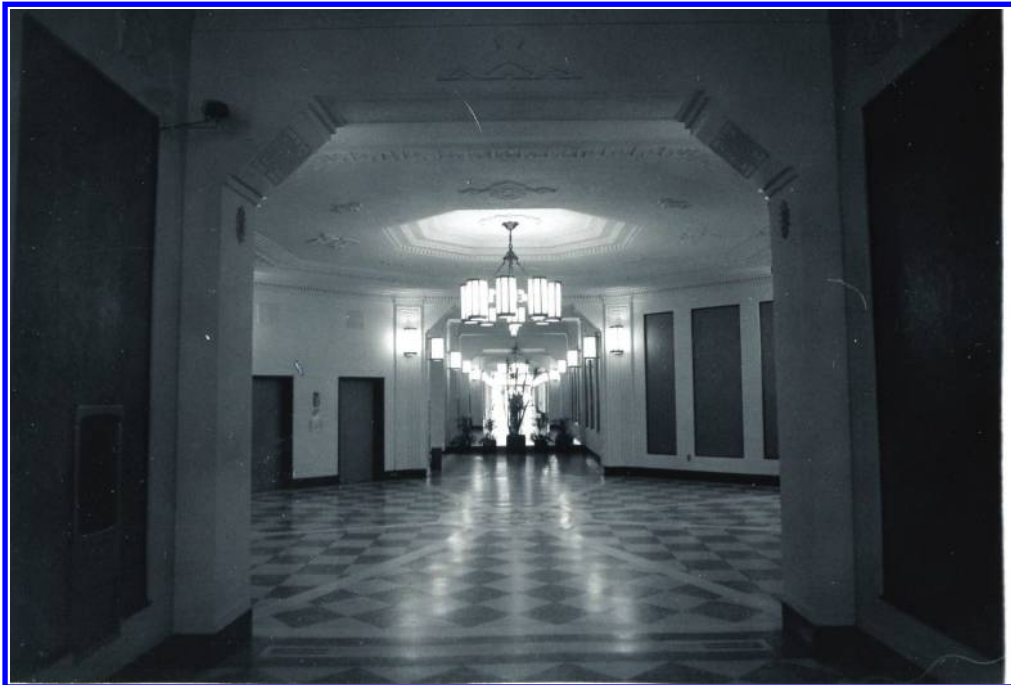
FIGURE 9: Broad-Grace Arcade Interior. c.1978. ©Virginia DHR Archives.

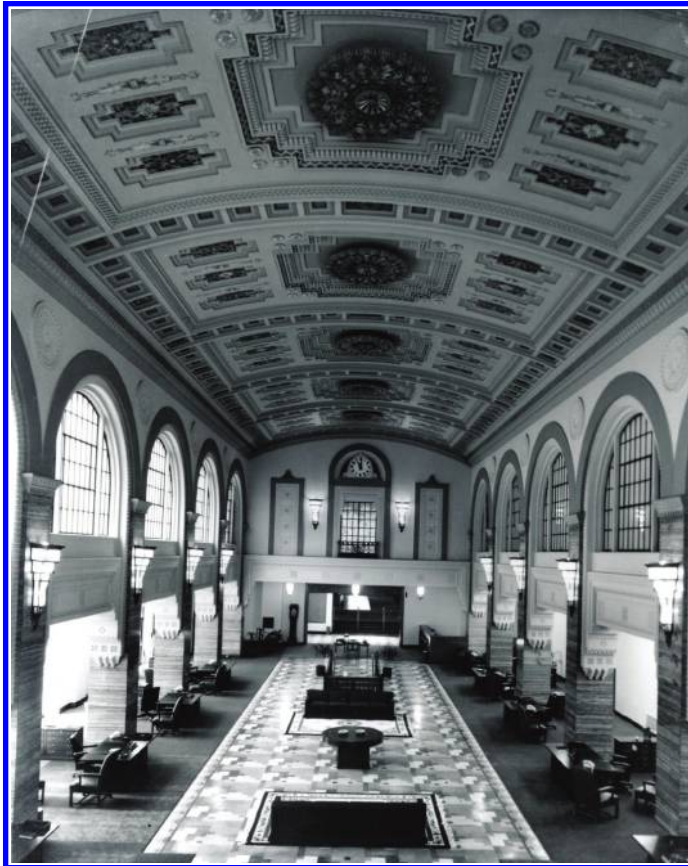
FIGURE 10: Banking Hall. c. 1930.
©Virginia DHR Archives.

The Banking Hall is an even greater example of rich Art Deco design and detailing. A vaulted, three-story space, the Banking Hall includes significant features such as a deeply coffered vaulted ceiling and a geometric patterned terrazzo floor, and makes extensive use of cast bronze for lamps and other furnishings, all designed in the Art Deco style. Arched glass transom windows flank the Banking Hall on the long sides and flood the space in beautiful natural light, giving the Banking Hall a monumental quality.

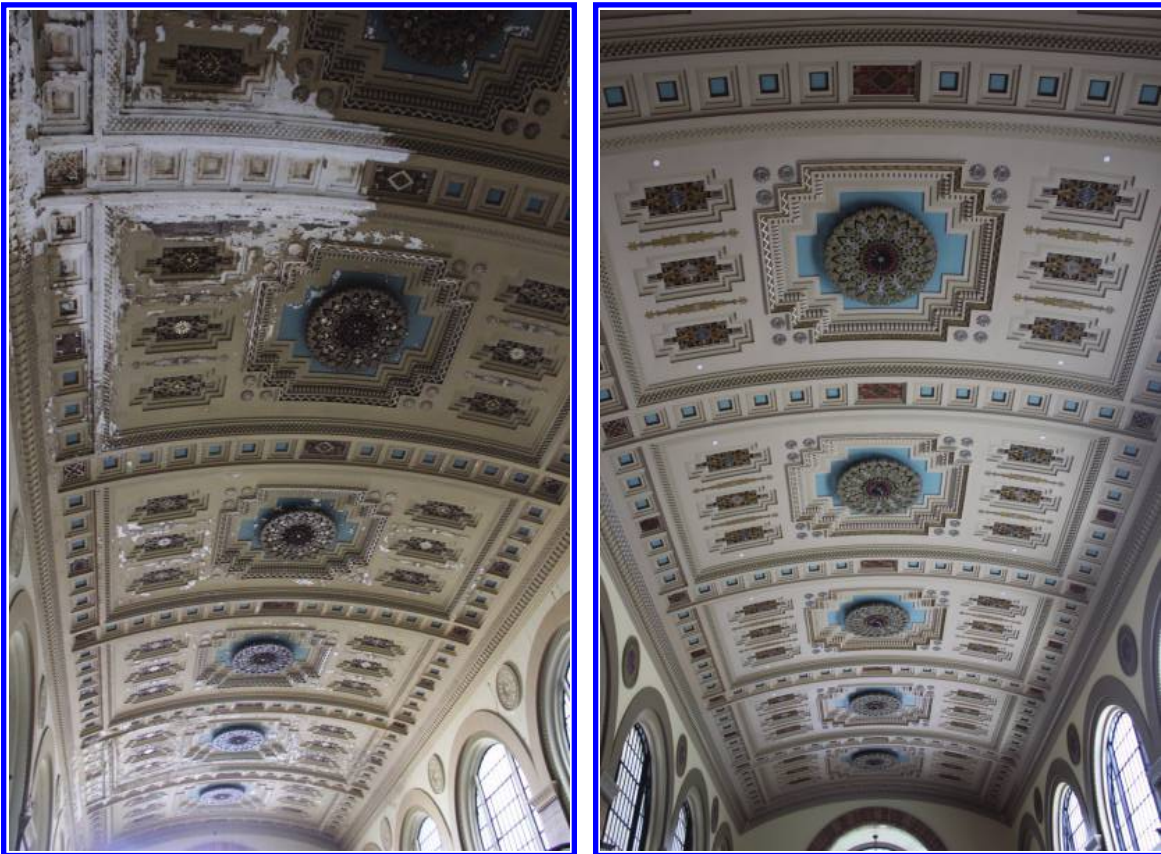
FIGURE 12: Before and After photographs of the vaulted ceiling of the Banking Hall. After photo shows the restored plaster detailing and historically accurate color scheme.

The restored Banking Hall, now returned to its original splendor of rich colors and Art Deco appointments, will become a restaurant with garden seating, currently scheduled for completion in the Fall of 2017. Future plans still include construction of a pool and spa area on the fourth floor roof of the annex, along with an outdoor lounge space for residents. All new work on the project is intended to be true to the original design intent of John Eberson.

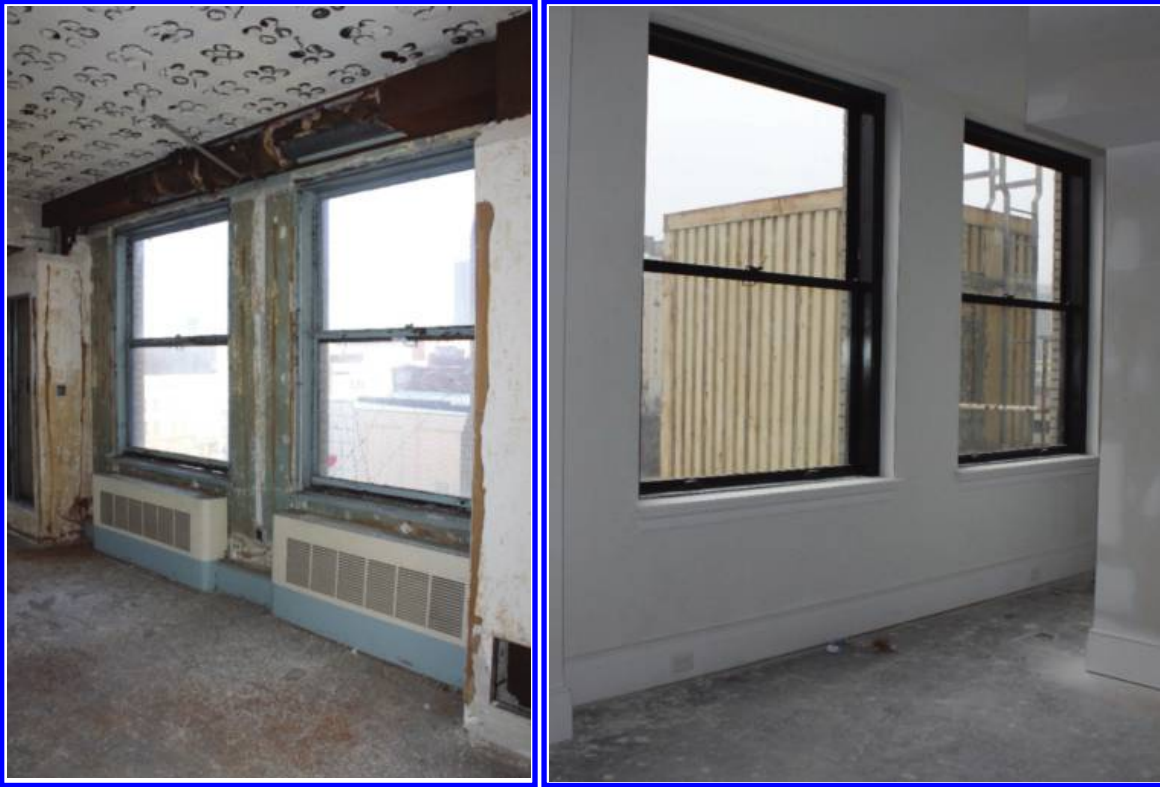
FIGURE 16: Before and after photographs of historic plaster walls in the Tower. After photo shows refurbished plaster and steel windows with “invisible” insulating interior storm units.

In the Tower portion of the CNB Building, the historic steel windows, extant from 1929, were in excellent condition, as was the interior plaster surface of the original exterior masonry walls. Because of this admittedly good historic news, the Virginia DHR required the project to repair and refurbish the windows and the interior plaster surfaces. In order to improve energy efficiency of the overall exterior enclosure, interior storm windows were installed behind the refurbished, but uninsulated, historic steel windows. The use of the storm units at the window penetrations of the masonry wall (even without any additional insulation added to the walls themselves) created an increase in the overall design efficiency of the mechanical systems by nearly 40%. By contrast, the existing interior plaster finish at the exterior walls of Annex was far beyond repair and so the project was allowed to install a new furring cavity of steel studs at the interior of the exterior walls, which was filled with new R-13 batt insulation to improve the thermal resistance for the wall.

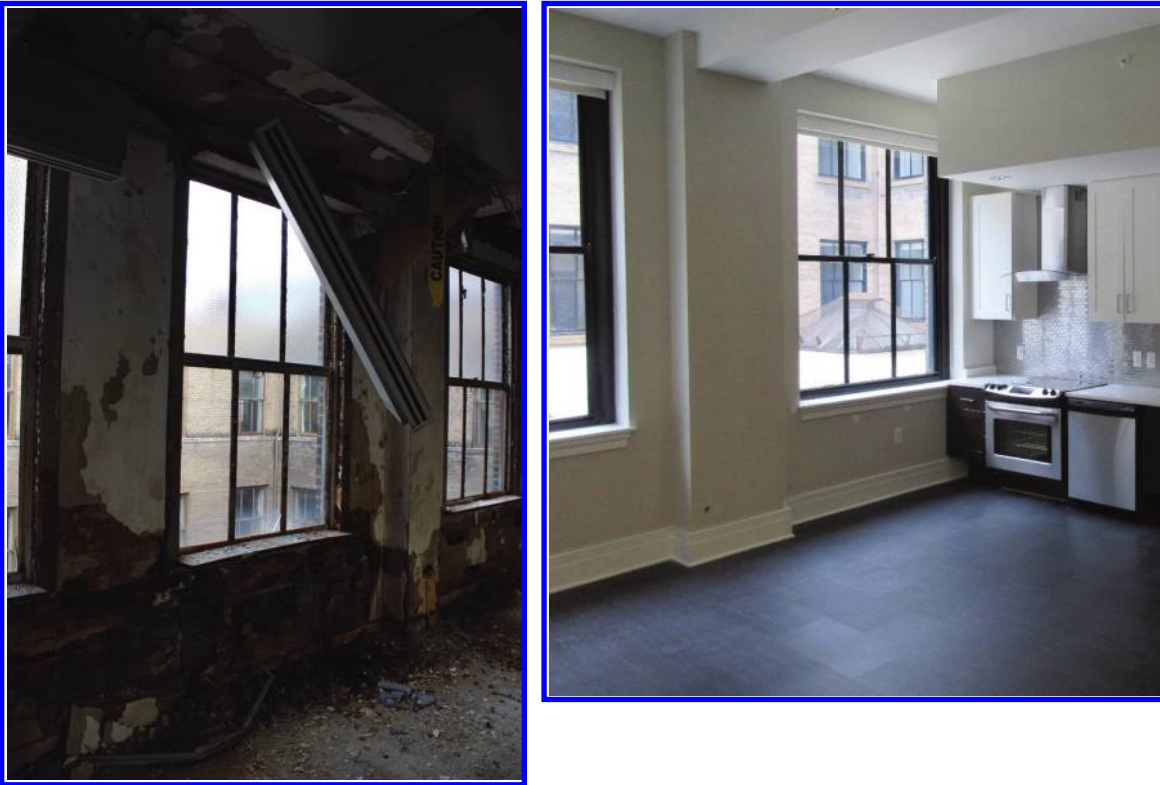
FIGURE 17: Before and after photos of Annex walls w/ insulated metal stud and gypsum board furring and refurbished steel windows

One challenging issue often encountered in this context is the potential for the addition of thermal insulation to the existing exterior enclosure assembly. While this is normally desirable from an energy standpoint, historic conditions may preclude the addition of insulation to the walls themselves. In this case, the goal is to do whatever is feasible within the limitations of what the DHR will allow to provide an overall increase in the energy efficiency of the building envelope.
